Manhole Inspection Summary

Manhole # S11YY1005MH

Insp Date: **7/19/06 10:40 AM**

Location Address: **5601 EVERHURST RD**

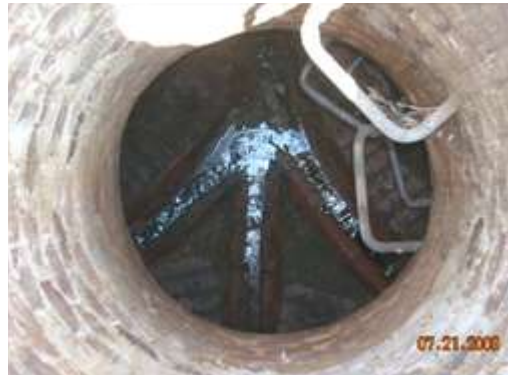
Top View

Evidence of surcharge - Bench debris.
Channel debris.

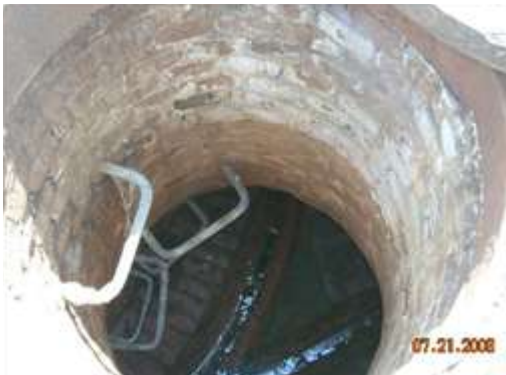
Defect

Frame leaks. Adjustment and Corbel deterioration and infiltration. Barrel infiltration.

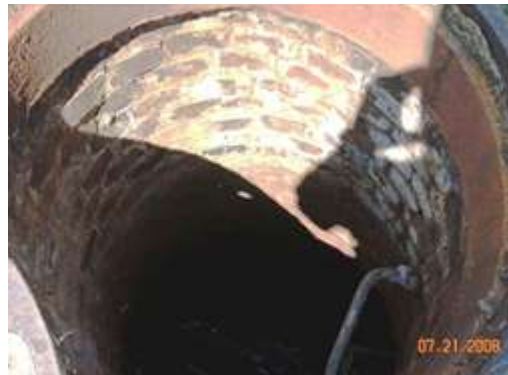
Defect

Frame leaks. Adjustment and Corbel deterioration and infiltration. Barrel infiltration - other side.

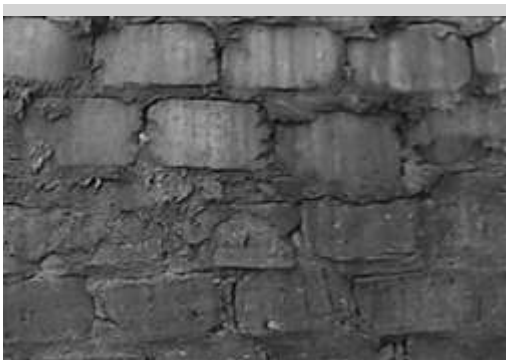
Defect

Corbel deterioration and infiltration.

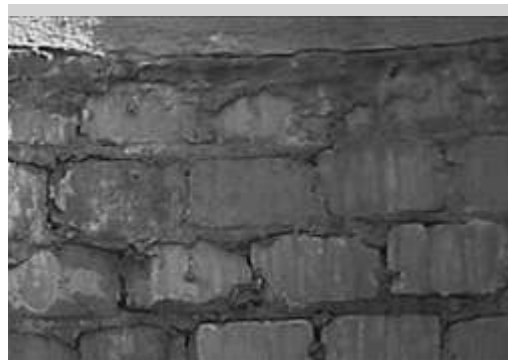
Defect

Frame leaks. Adjustment deterioration and infiltration.

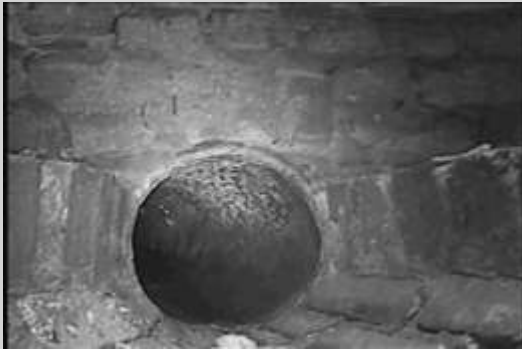
8 in. Circular Gravity Sewer Pipe Out @ 12 O'Clock

Infiltration: **Evidence** Pipe Seal Cond: **Unknown**

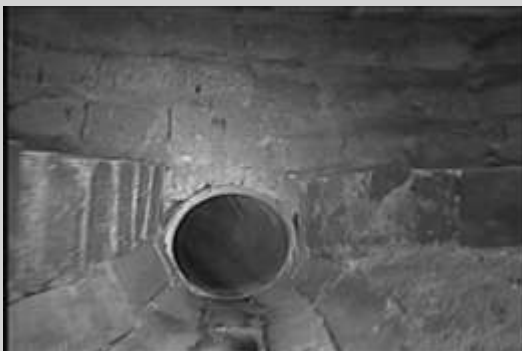
6 in. Circular Gravity Sewer Pipe In @ 4 O'Clock

Infiltration: **Evidence** Pipe Seal Cond: **Cracked**

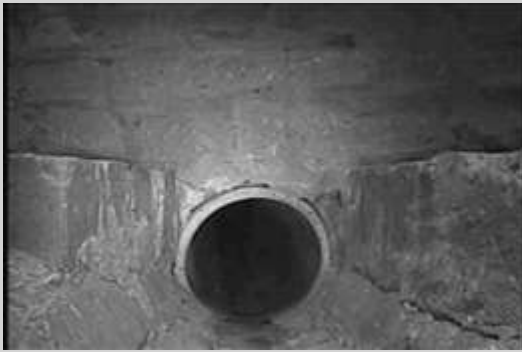
6 in. Circular Gravity Sewer

Channel deterioration.

Infiltration: **Evidence** Pipe Seal Cond: **Cracked**

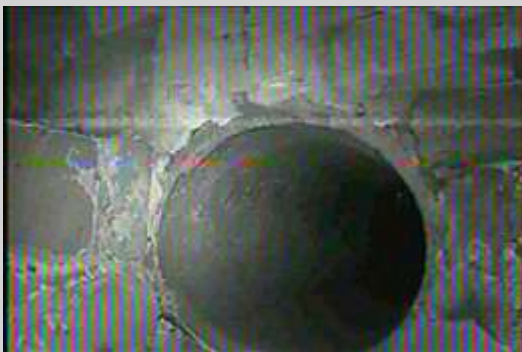
8 in. Circular Gravity Sewer

Infiltration: **Evidence** Pipe Seal Cond: **Unknown**
